DODIG-2015-013

OCTOBER 28, 2014

Military Housing Inspections – Republic of Korea

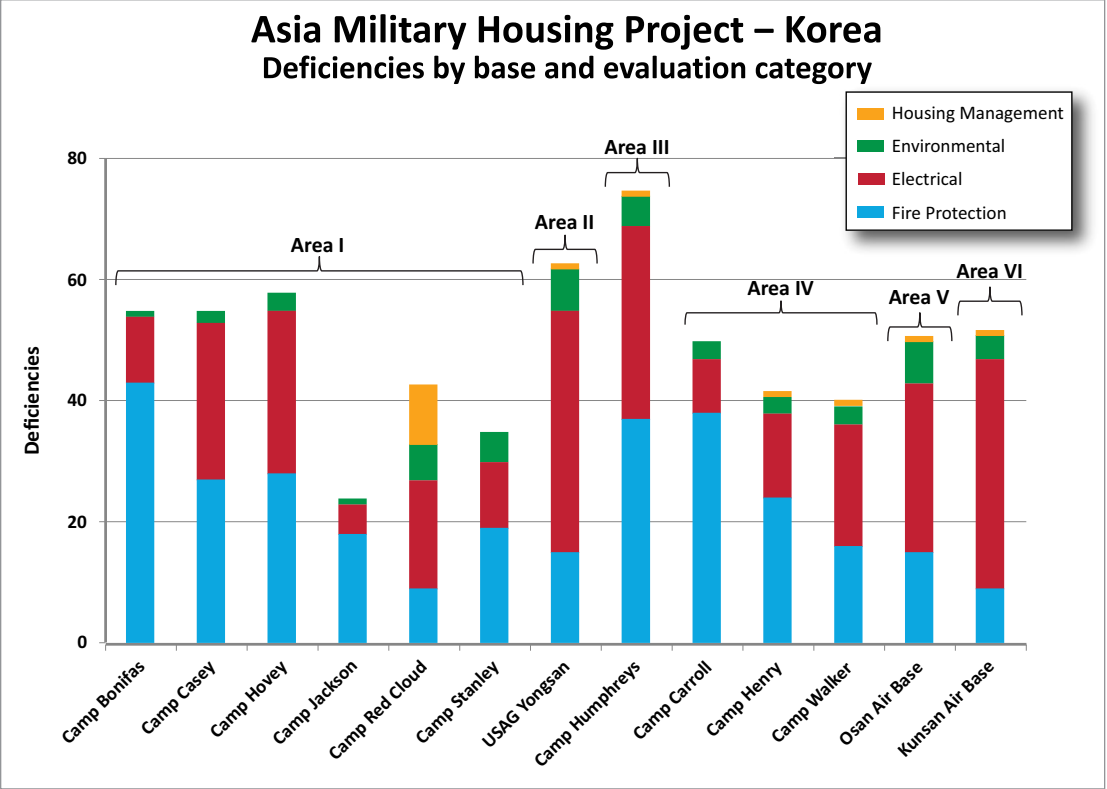
Figure 2. Number Of Deficiencies By Base Installation And Evaluation Category

During the housing inspections at 13 military installations in the Republic of Korea, we documented 646 deficiencies (violations of code) affecting the life, health, and safety of warfighters and their families (see Appendix G). Deficiencies documented noncompliance with the UFC, NFPA, NEC, EGS, environmental standards, DoD policies and instructions, Armed Services policies, and internal procedures and processes at each facility. Deficiencies were classified into four primary categories: fire protection, electrical, environmental health and safety, and housing management. Environmental health and safety deficiencies were further delineated into the following subcategories: mold, asbestos/lead/polychlorinated biphenyls (PCBs), radon, water quality, pest infestation, and radiation. Based on the time of the year during which the inspections were conducted, an additional subcategory for Heating, Ventilation, and Air Conditioning (HVAC) systems was created to capture poorly maintained HVAC systems as they contribute to conditions conducive to mold growth. As we performed the ROK inspections in the March-April timeframe, we were not in Korea at the time of year when mold is in season, we therefore focused on HVAC systems as that leads to conditions conducive to mold growth. An additional subcategory was created to capture deficiencies related to spill containment practices for environmental contaminants that were found as being employed during the course of these inspections. Contamination deficiencies include the fuel tanks without a secondary containment system to control fuel leaks, oil spills and unmitigated volatile organic compounds. Our evaluation of housing management included an inspection of processes, databases, and components responsible for overall implementation of

housing policies. Figure 2 shows deficiencies in the four evaluation categories. Based on our radiation measurements, the estimated individual annual doses at each USFK installation were very low. At these levels, there are no demonstrable radiation-induced health effects.

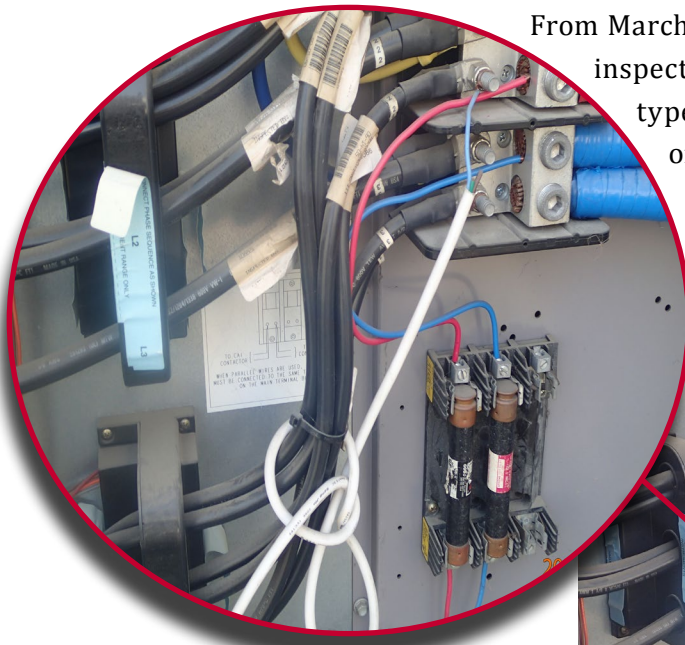
action (out of the 75 deficiencies identified at Camp Humphreys). These deficiencies included an entire building not grounded, an exposed energized wire inside an elevator motor, and an extension cord incorrectly hard-wired to a high-powered electrical panel (see Figure 7). We also found that the drinking water supply had not been tested monthly for coliform bacteria since July 2013 as required by the USFK EGS.

Figure 7: A drop cord hard-wired directly to conductors fused at 400 Amps inside the chiller electrical power panel (Deficiency No. HUM-EL-140331-021A)
Source: DoD OIG

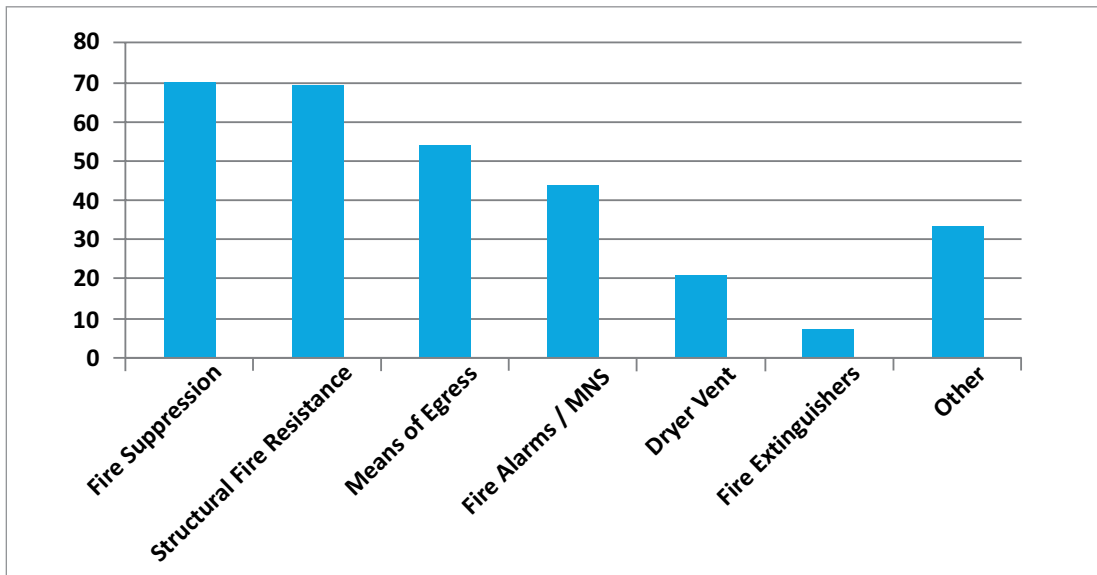
Figure 12. Fire Protection Deficiencies

We found 298 fire protection deficiencies. Figure 12 shows the breakdown of all the fire protection deficiencies in the relevant subcategories.

We found deficiencies in the fire suppression systems throughout installations in Korea. For example, many buildings had sprinkler systems that were broken, not maintained, improperly installed, or missing altogether. In the area of structural fire resistance, we found fire doors that were propped open, damaged, not rated, or were missing closers. We also found deficiencies in the means of egress. For example, many buildings did not have adequate emergency lighting in the fire escape stairways and hallways. Fire alarm deficiencies included missing carbon monoxide detectors and missing or broken fire alarms. Dryer vent transition ducts were bent, crushed, disconnected, pinched, or clogged and were not constructed

of fire rated material. We found a lack of periodic inspection of fire extinguishers, many with low levels of extinguishing agent. Other deficiencies were items stored in prohibited locations, heating oil leakage in areas where ignition is probable, and excessive lint build-up in laundry rooms. These deficiencies increase the risk of fire, loss of life, and property.

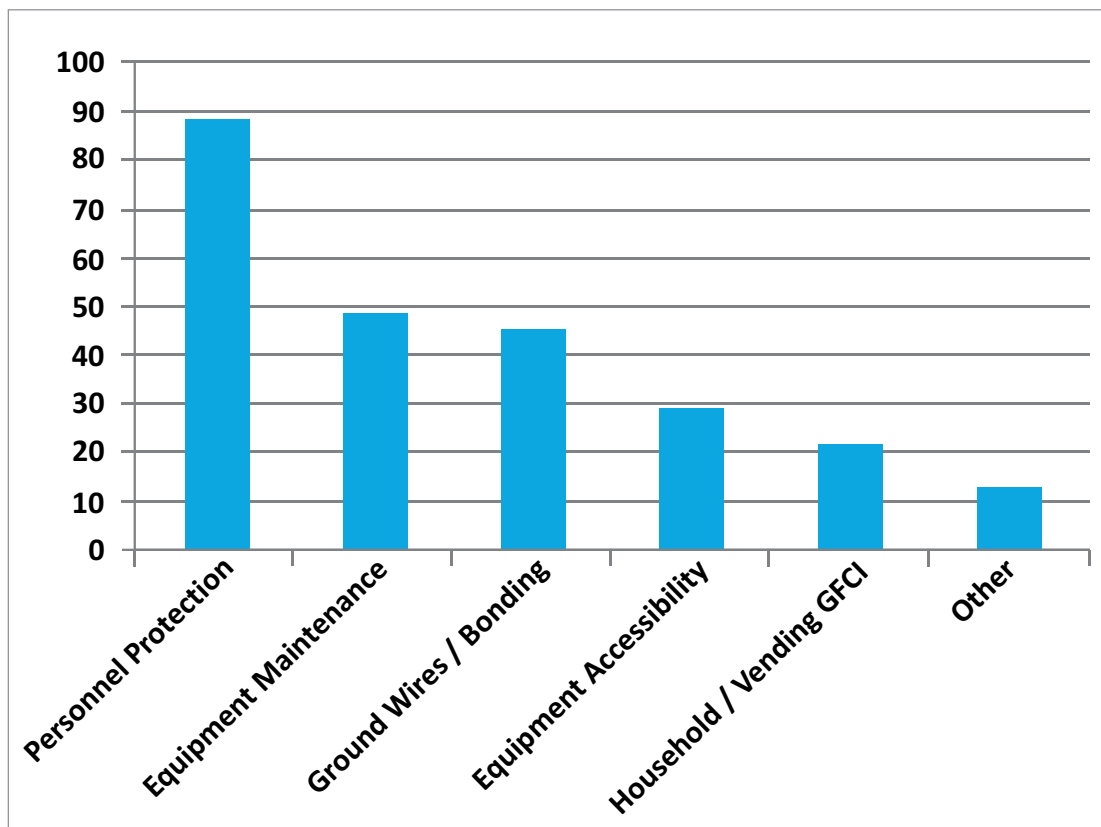
Figure 13. Electrical Deficiencies

We identified 279 electrical deficiencies. Figure 13 shows the breakdown of the electrical deficiencies in the relevant subcategories.

Personnel protection deficiencies included exposed wires not contained or protected by junction boxes in mechanical rooms, missing electrical service panel breaker blanks or broken electrical covers, incomplete or broken electrical conduits, missing light fixture covers in damp and wet locations and within reach

of personnel in the shower, and missing knockout seals and covers in a junction box. In the area of equipment maintenance, we found electrical service-drop conductors providing electricity to the main electrical panel of the house that were too low, corrosion on junction boxes, and many buildings being served by multiple service drops. Also, we found inadequate or nonfunctioning climate control for electrical rooms and equipment. Ground wires/bonding issues included unbonded main electrical panels, and water circulating pumps with disconnected ground wires. Equipment accessibility deficiencies included junction boxes and electrical panels that were obstructed and inaccessible. We found lack of GFCI protection in laundry rooms, outside areas, vending machines, and water coolers. Other deficiencies included electrical panels with missing or incorrectly labeled directories, incorrect fittings being used to connect a conduit, and receptacles wired for incorrect voltage. These deficiencies create a risk of fire, electric shock, or electrocution for installation personnel and occupants.

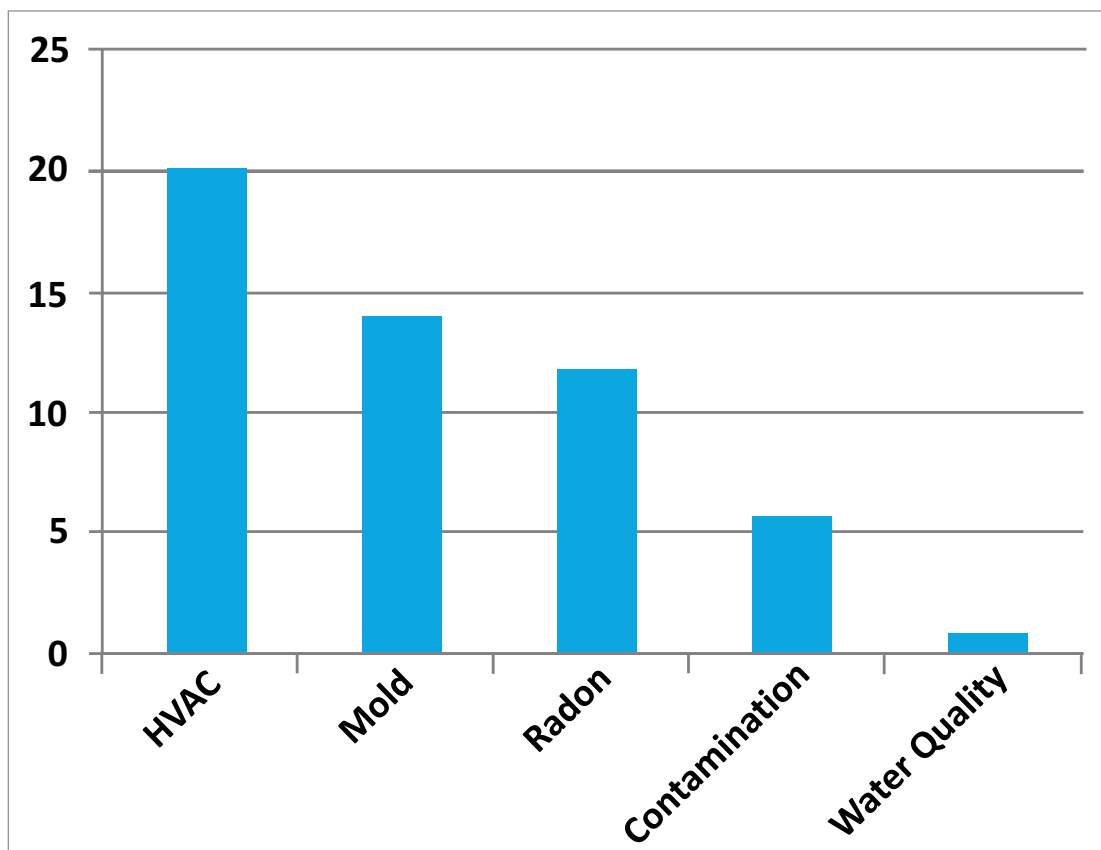
Figure 14. Environmental Health and Safety Deficiencies

We identified 53 deficiencies relating to environmental health and safety. Figure 14 shows the breakdown of all of the environmental deficiencies in the relevant subcategories.

We found a lack of properly maintained HVAC units, fan coil units, filters, and plumbing system pipes. Air handling units (AHU) were broken and out of service for extended periods, which could allow moist air to enter the building through negative pressure and cause mold growth. In unaccompanied units, responsibilities were not clearly defined between building occupants and managers for operating and maintaining air handling system components in living quarters or for addressing water leaks and mold problems. In addition, there is no DoD-wide policy or guidelines on mold mitigation and control. Mold may increase the potential for respiratory illness and other mold and indoor air quality-related health issues.

We found that radon surveys and databases were not maintained at several installations. Installation personnel were not performing post-mitigation monitoring to ensure existing radon mitigation systems were functioning. We also found a lack of guidance on radon surveillance, mitigation, and control despite EPA studies stating that radon is a carcinogen that causes thousands of deaths each year. For example, OEBGD does not provide guidance on radon. UFC 4-711-01 provides guidance on radon for accompanied housing but not for unaccompanied housing. Furthermore, a Department of the Army Radon Reduction Program was superseded by Army Regulation (AR) 420-1, "Army Facilities Management," which refers to AR 200-1, "Environmental Protection and Enhancement," for radon action level guidelines; however, AR 200-1 has no reference to radon. Further details of our inspection relating to radon can be found in Appendix B.
